**LABORATORY REPORT**  
 GETRAG S.p.A. - B/WLQ 2

**REPORT 14/125**

**Reason for analysis:** PPAP + Full Layout dimensional

**Part Name:** SR5

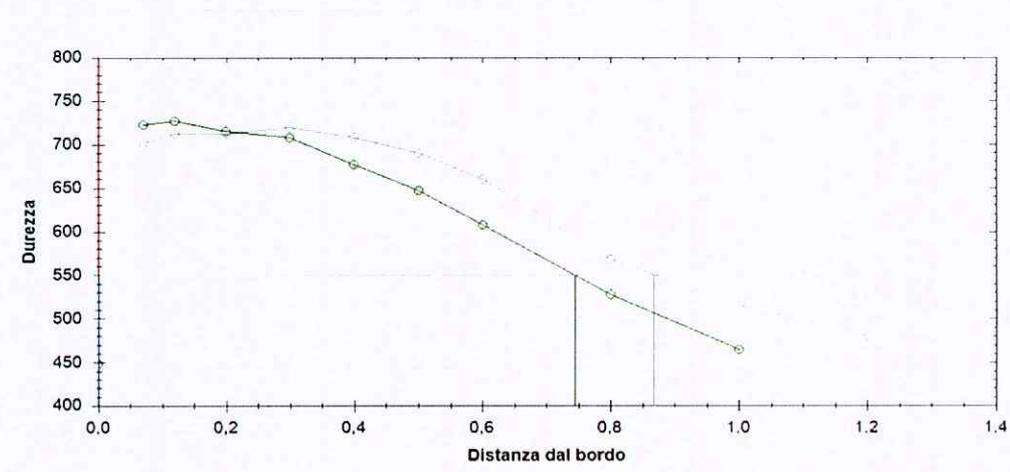
Picture 1: gear - Hardness profiles

Sample		Position	Values [mm]	Range	Component
2095/14	CHD 550 HV1	M2	0,87	0.5 + 0.4 mm	Gear
2095/14	CHD 550 HV1	M3	0,75	min. 0.3 mm	Gear
2095/14	CHD 550 HV1	M1	0,58	0.4 + 0.4 mm	Engagement ring

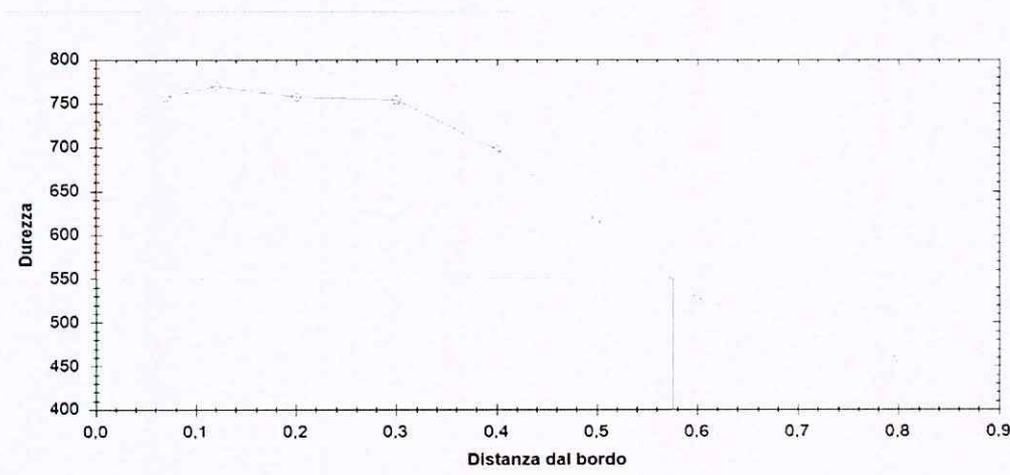
Picture 2: Engagement ring - Hardness profiles

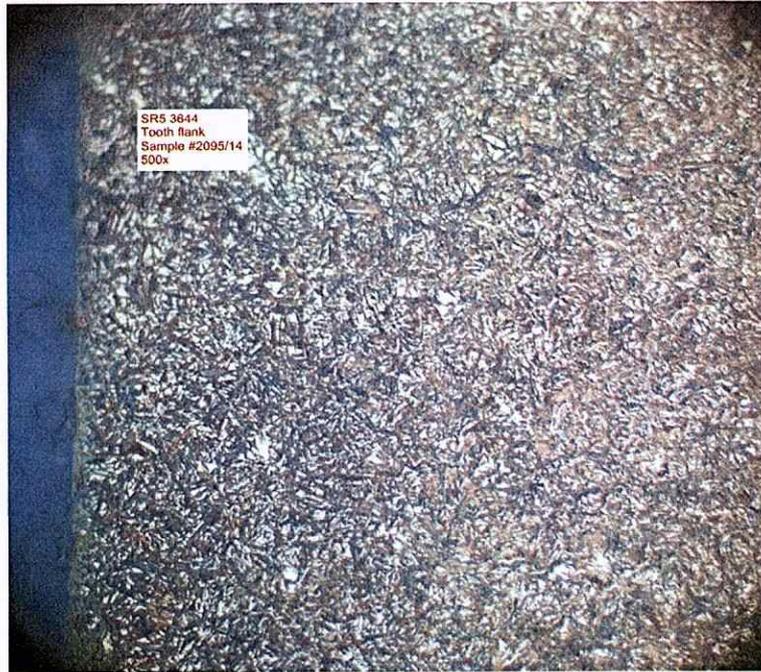
Sample #	2095/14
Gear - Tooth flank surface structure:	Martensite + 15±20% retained austenite (OK)
Gear - Tooth base core structure:	Martensite + bainite (OK)

Picture 3: Gear - Surface microstructure at tooth flank (X500)

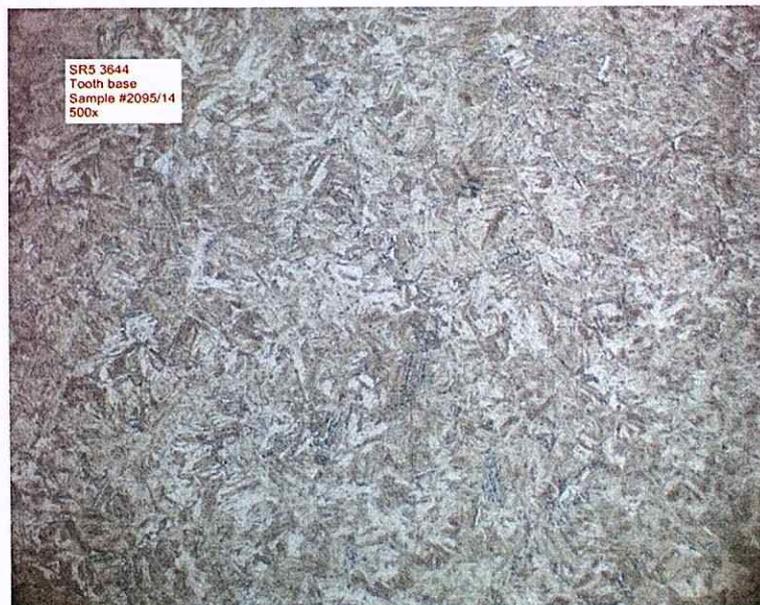
Picture 4: Gear - Core microstructure at tooth base (X500)

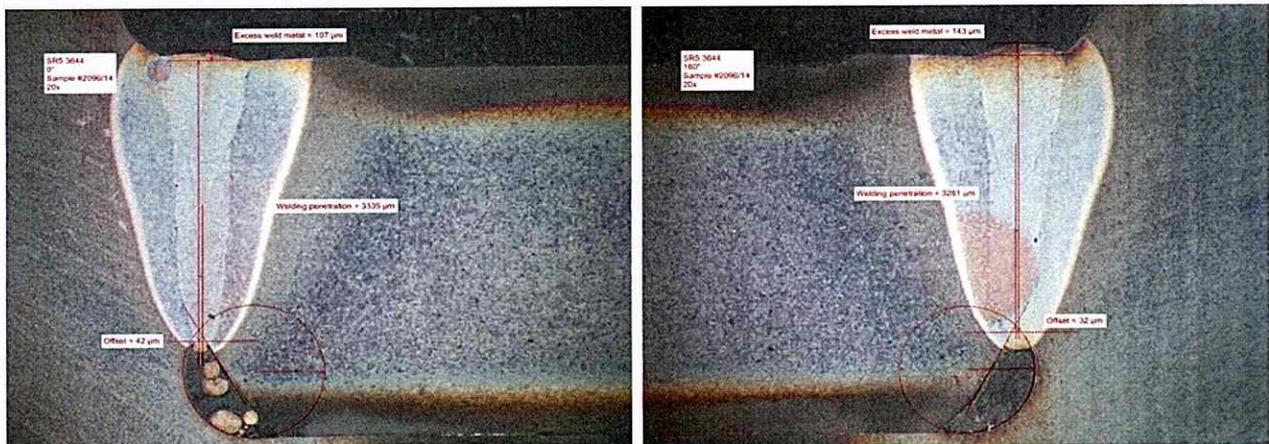
Position	Welding penetration [mm]	offset [mm]	Excess weld metal [mm]
Sample # 2096/14	0°	3,335	0,042	0,107
Sample # 2096/14	180°	3,281	0,032	0,143
Range		min 2,8	max ± 0.1 mm	max 0.5 mm

Picture 5: macro of the joint
