LABORATORY REPORT
 GETRAG S.p.A. - B/WLQ 2

REPORT 13/156

Reason for analysis:	Full Layout dimensional
-----------------------------	-------------------------

Part Name:	DG
P/N:	250.1.3692.76
State of parts:	Finished

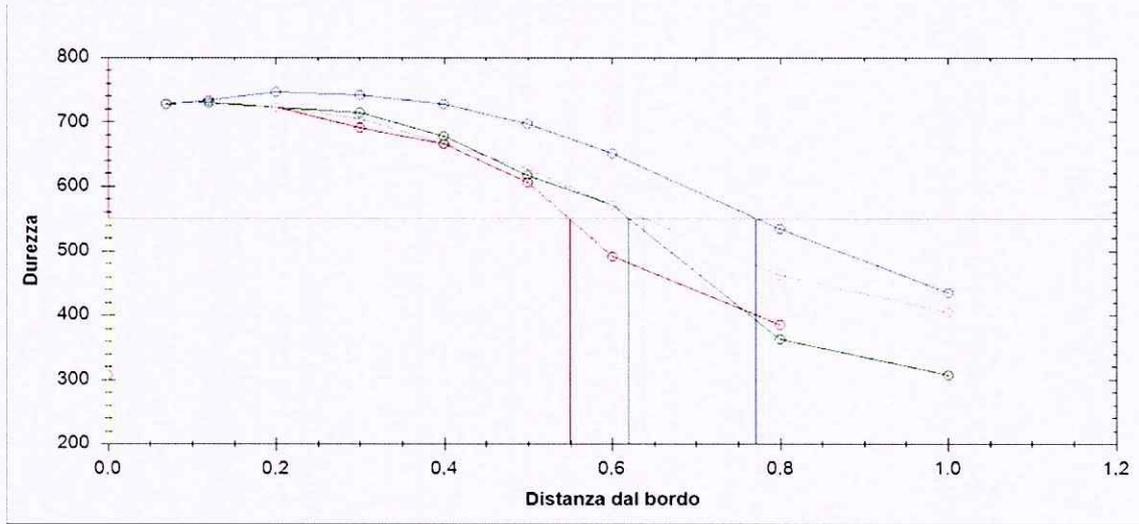
Picture 1: Hardness profiles

Sample	Scale	Position	Values [mm]	Range [mm]	Component
3802/13	CHD 550 HV1	M2	0,64	0.5 + 0.4	Gear 2nd
3802/13	CHD 550 HV1	M2	0,62	0.5 + 0.4	DG-Rev
3802/13	CHD 550 HV1	M2	0,77	0.5 + 0.4	Clutch Ring
3802/13	CHD 550 HV2	M3	0,55	min. 0.3	DG-Rev

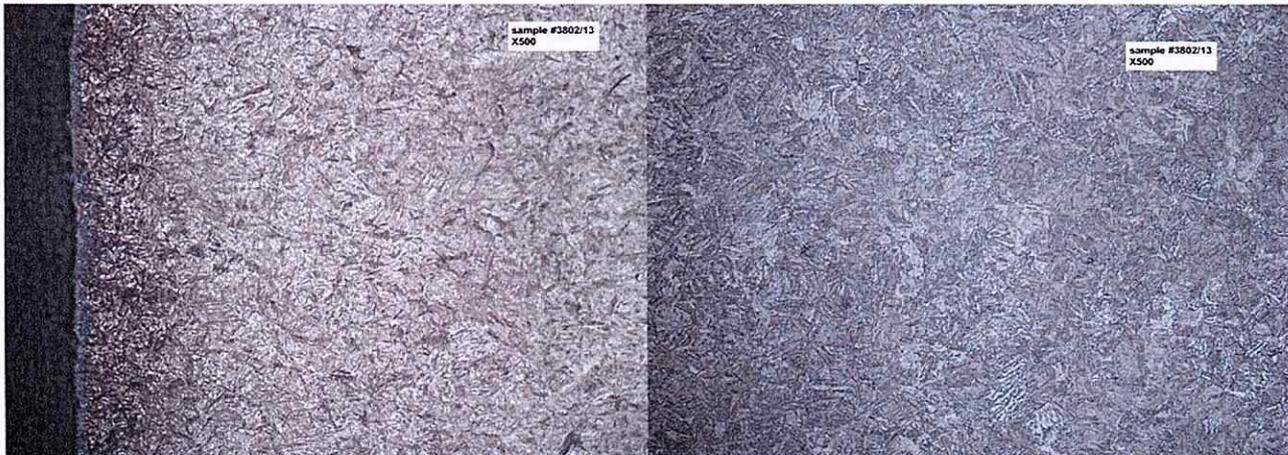
Picture 2: Gear-2nd surface microstructure at tooth flank (left) and at tooth root (right).

Sample # 3802/13	Gear 2nd
Gear - Tooth flank surface structure:	Martensite + 5% retained austenite (OK)
Gear - Tooth base core structure:	Martensite + bainite (OK)

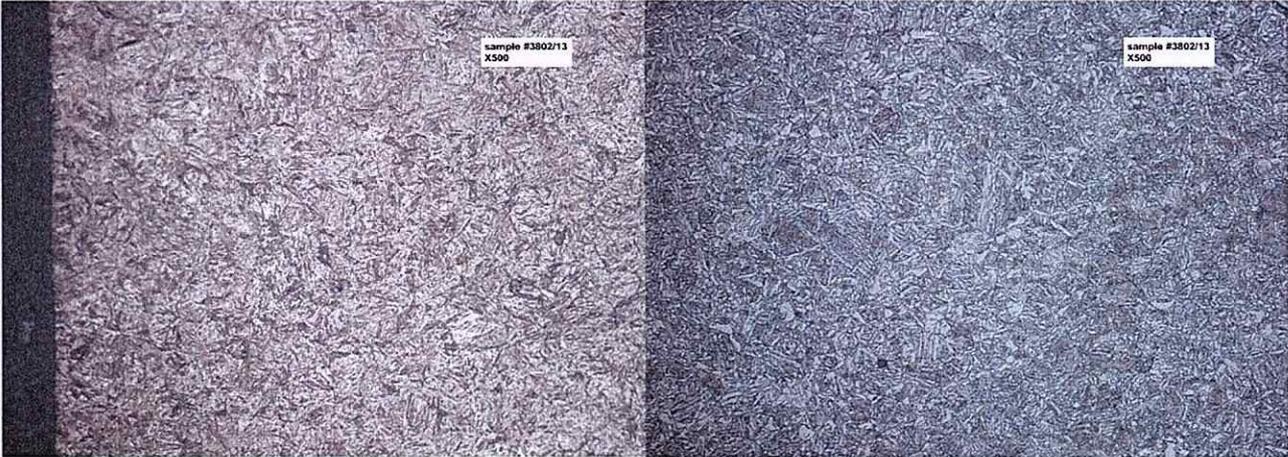
Picture 2: DG-Rev surface microstructure at tooth flank (left) and at tooth root (right).

Sample # 3802/13	DG-Reverse
Gear - Tooth flank surface structure:	Martensite + 5% retained austenite (OK)
Gear - Tooth base core structure:	Martensite + bainite (OK)

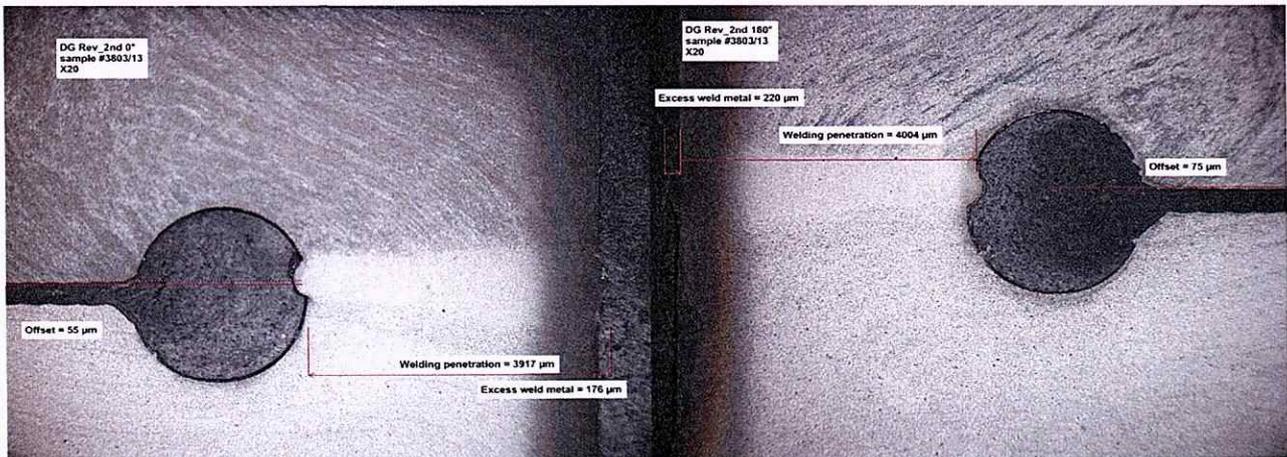
Picture 3: macro of the joint

Sample #	Position	Welding penetration [mm]	Offset [mm]	Excess weld metal [mm]
3803/13	DG-Rev-Gear 2nd 0°	3,92	0,055	0,176
3803/13	DG-Rev-Gear 2nd 180°	4	0,075	0,22
Range		full penetration	max ± 0.1	max 0.5
Magnetic particles insp.	No defective indication

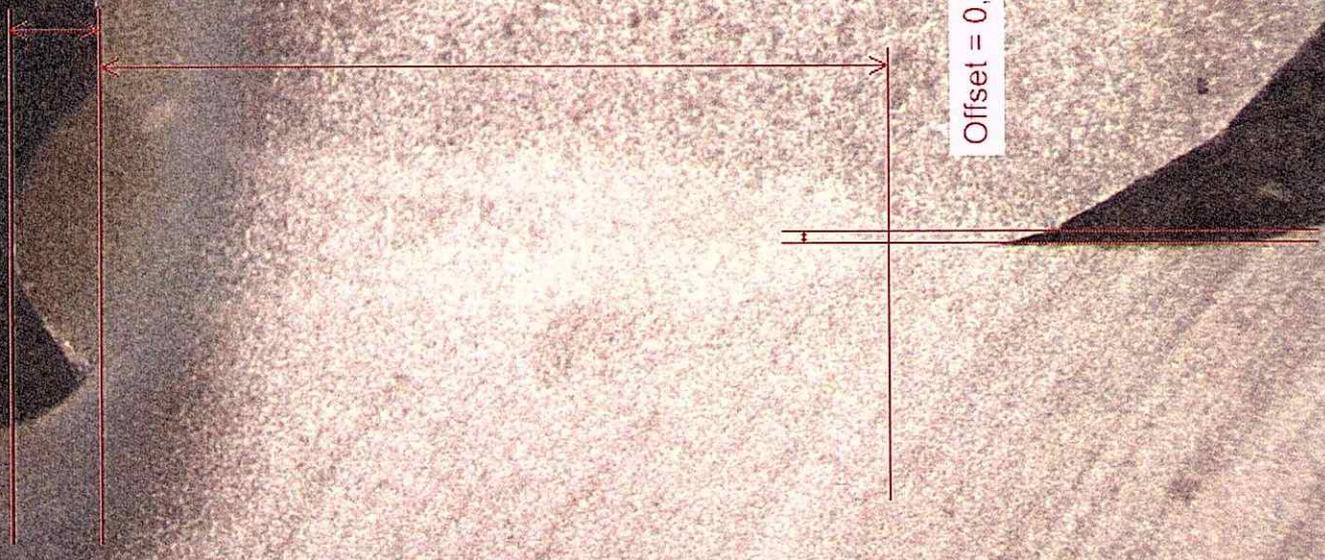
P/N 3692
Sample#3832/13
X16
11_10_2013

Excess weld metal = 0,37 mm

Welding penetration = 3,19 mm

Offset = 0,06 mm
