REPORT 14/076

*Metallographic Analysis*

DCT Shafts

Part Name: Input Shaft inner

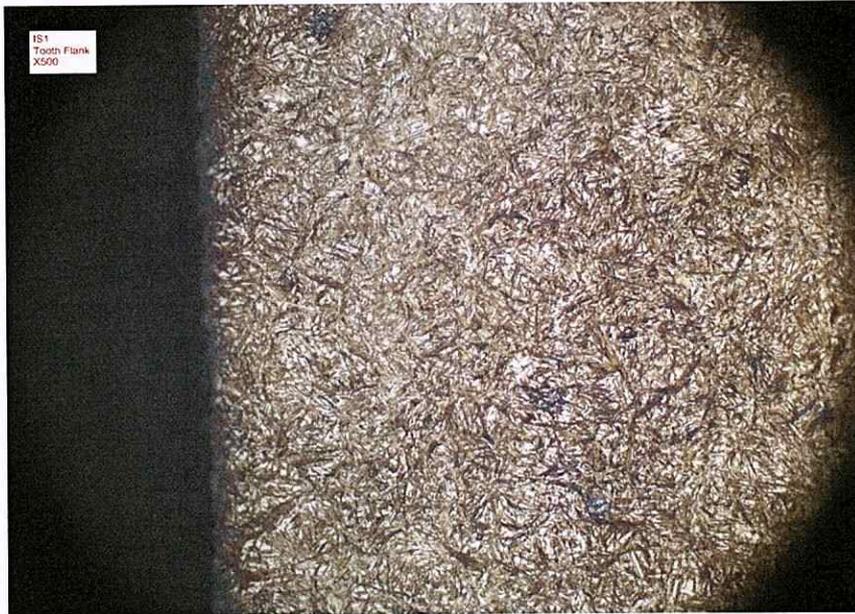
Sample # 1440/14	IS1
Tooth flank surface structure:	Martensite + 10% retained austenite (OK)
Tooth base core structure:	Martensite + bainite (OK)

Picture 2: Surface microstructure at tooth flank (X500)

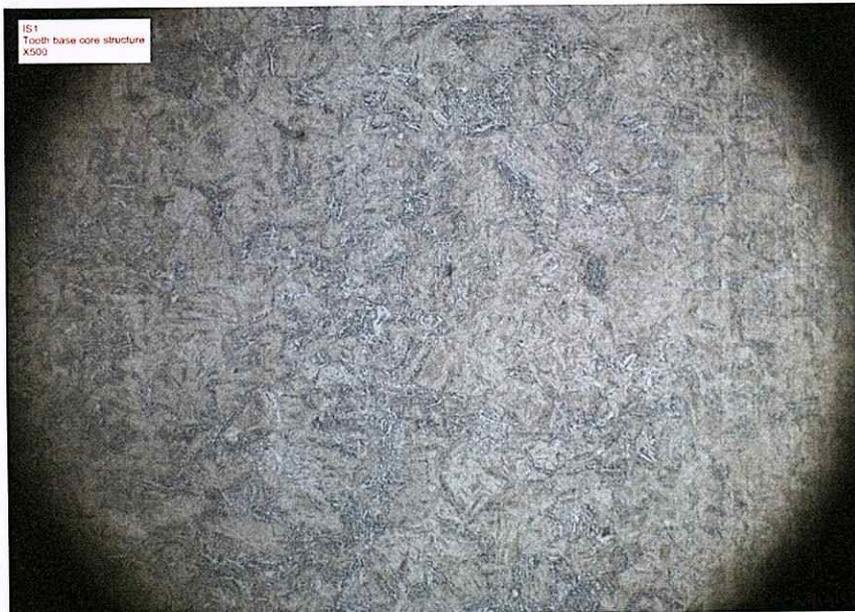
Picture 3: Core microstructure at tooth base (X500)
